REPORT DOCUMENTATION PAGE		READ INSTRUCTIONS BEFORE COMPLETING FORM
1. REPORT NUMBER	2. GOVT ACCESSION NO.	3. RECIPIENT'S CATALOG NUMBER
	4D-A109786	
4. TITLE (and Subtitle) Phase I Inspection Report Beebe Lake Dam Oswego River Basin, Tompkins County, NY Inventory No. 394		5. TYPE OF REPORT & PERIOD COVERED Phase I Inspection Report National Dam Safety Program

PHASE I INSPECTION REPORT
NATIONAL DAM SAFETY PROGRAM
BEEBE LAKE DAM
N.Y. 394
DEC I.D. NO. 75A-691
OSWEGO RIVER BASIN
THOMPkins COUNTY, NEW YORK

Name of Dam:	Beebe Lake Dam N.Y. 394
State Located:	New York
County Located:	Thompkins
Stream:	Fall Creek
Date of Inspection:	March 26, 1981 and June 3, 1981

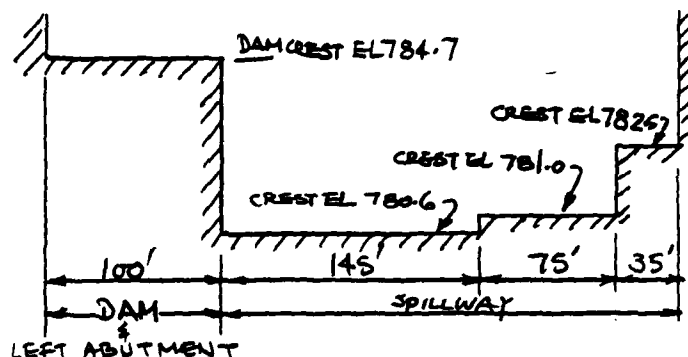
PRO FILE OF DAM AND SPILLWAY CREST
 (LOOKING D/S)

SPILLWAY RATING

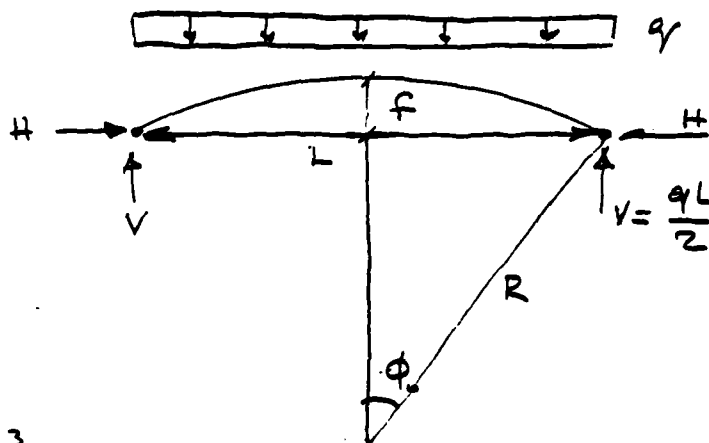
CHECK ARCH STRESS @ MID HEIGHT OF DAM

$$\text{SLICE AREA} = 144(12 \times 1) \\ = 1728 \text{ in}^2$$

$$I_{y-y} = \frac{bh^3}{12} = \frac{(1 \times 12) \times (12 \times 12)^3}{12} \\ = 3 \times 10^6 \text{ in}^4$$

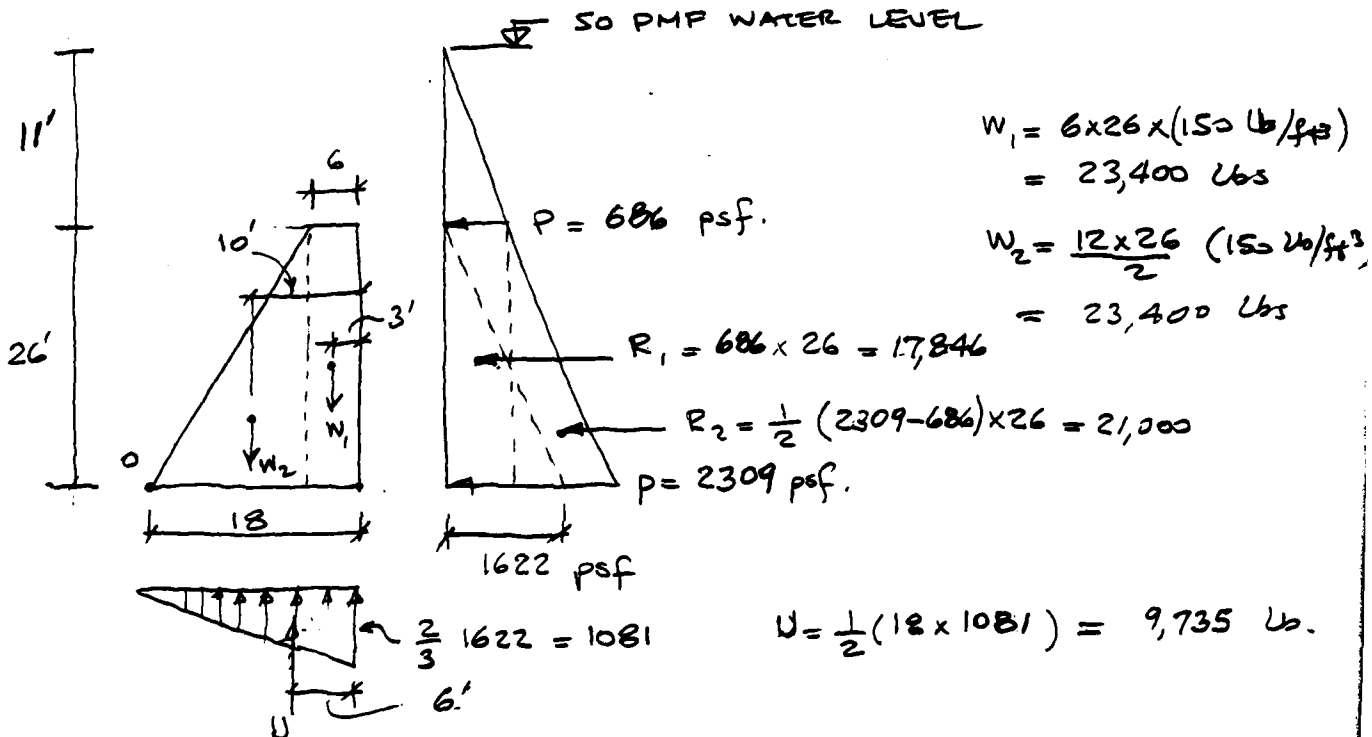
CHECK STABILITY ASSUMING THE DAM TO BE A GRAVITY STRUCTURE

LOADING : 50 % PMF OVERTOPPING : 11 ft.

MOMENTS ABOUT PT 'O'

$$\begin{aligned}
 M &= 15 W_1 + 8 W_2 - 12 U - 13 R_1 - \frac{26}{3} R_2 \\
 &= (351 + 187 - 117 - 232 - 183) \times 10^3 \text{ ft-lbs} \\
 &= (538 - 532) \times 10^3 = 6 \times 10^3 \text{ lb-ft.}
 \end{aligned}$$
